# Manhole Inspection Summary

Manhole # S35U\_\_013MH

Insp Date: **3/13/08 9:40 AM**

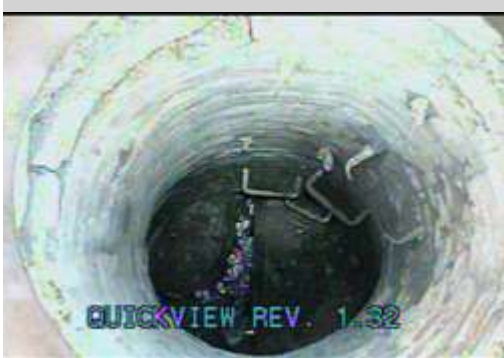
Defect 1

Condition: ☐ Sound ☐ Cracked ☐ Root Intrusion ☐ Loose Brick ☒ **Deteriorated**

Infiltration: ☐ None ☐ Joint ☐ Cracks ☐ Mortar ☐ Roots ☒ **Wall**

Count: **6** Missing: **3** ☒ **Corroded**

deteriorated chimney with signs of chimney and corbel infiltration, corroded steps

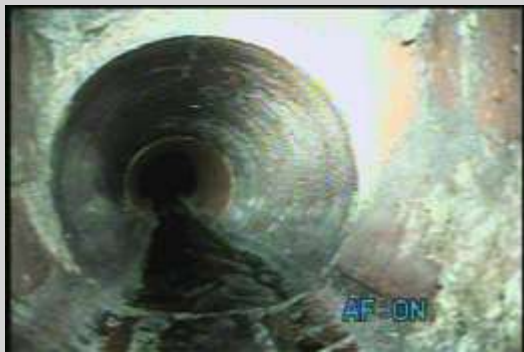
12 O'Clock Outflow

8 in. Circular Gravity Sewer  
Pipe Out @ 12 O'Clock

Infiltration: **None** Pipe Seal Cond: **Unknown**

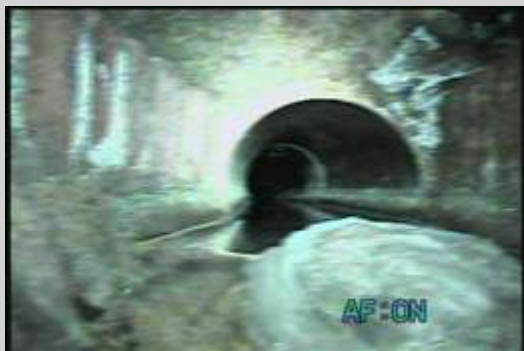
6 O'Clock Inflow

8 in. Circular Gravity Sewer  
Pipe In @ 6 O'Clock

Infiltration: **None** Pipe Seal Cond: **Unknown**

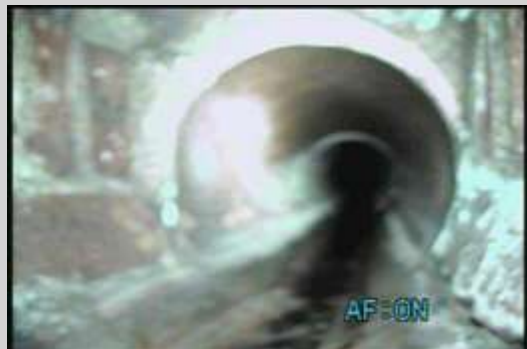
7 O'Clock Inflow

Pipe In @ 7 O'Clock

Infiltration: **None** Pipe Seal Cond: **Unknown**
